**Subsidence Documentation Study**  
**Sufco Mine**  
**May 30, 2003**  
**Summary**

The data contained in this binder is a compilation of subsidence features gathered in the field from the 19 of May to the 22 of May 2003. The features have been organized into five different sections representing panels in descending order starting with the most recent. At the beginning of each section is a summary sheet outlining important aspects of the panel with emphasis on subsidence features contained therein.

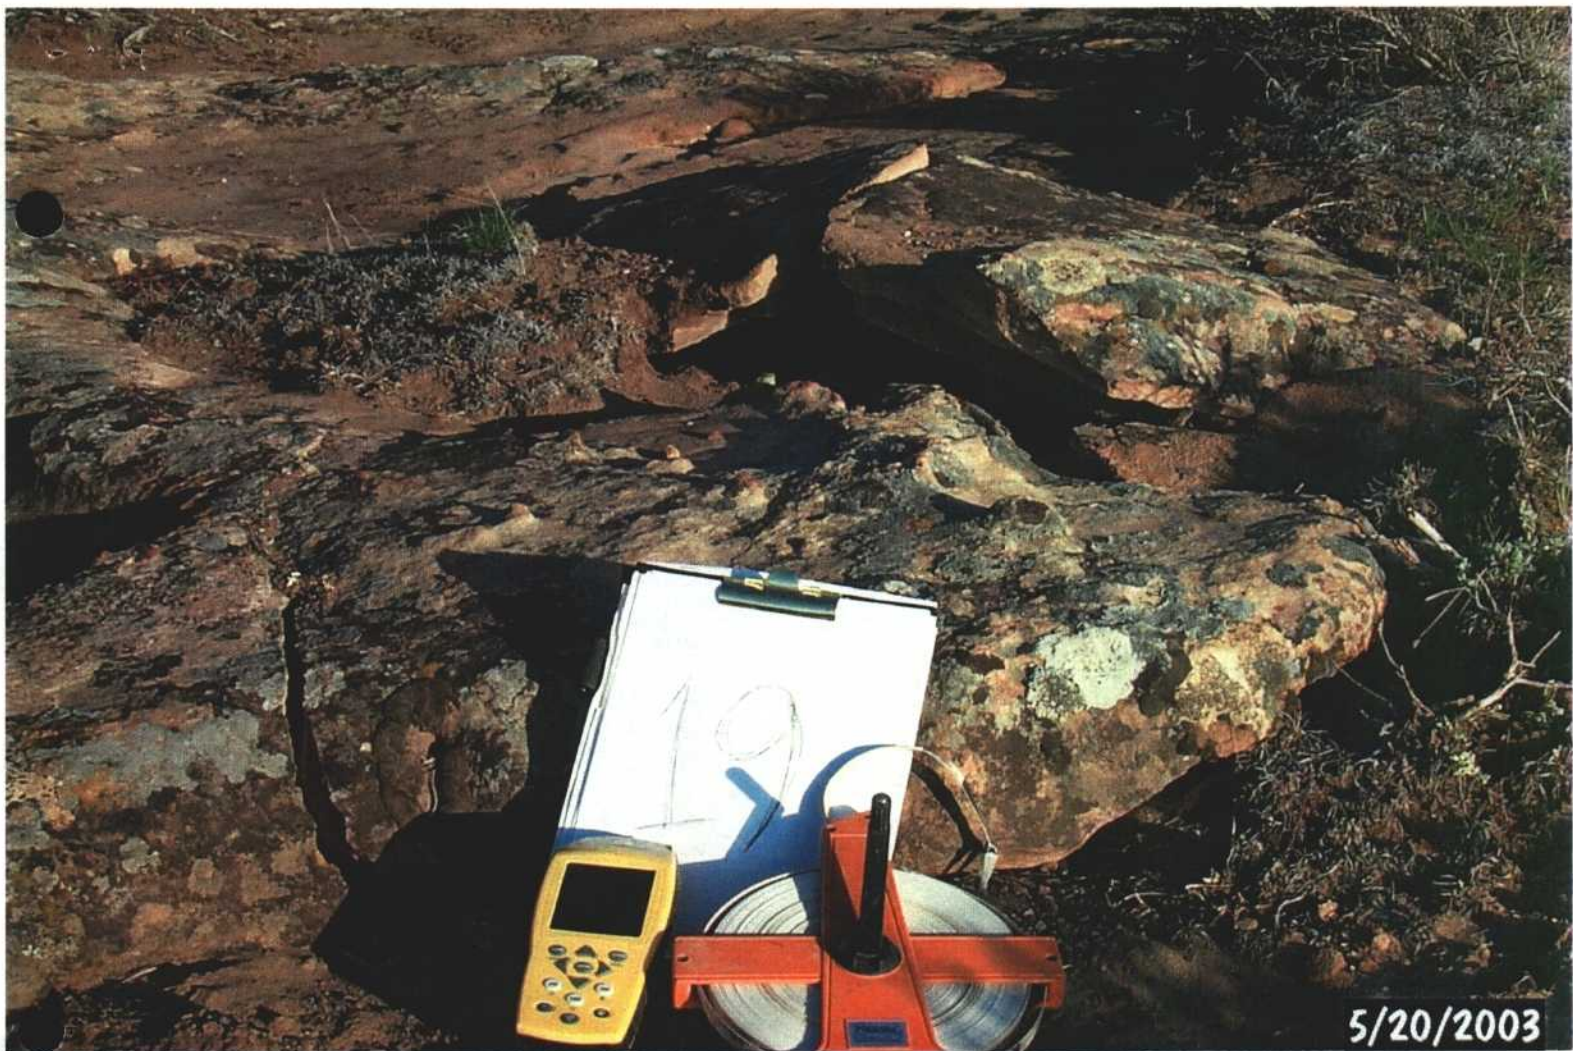
5/20/2003

Potential Hazards? Not apparent.

Other Comments (seeps, stream channel, archeological, eagle nest) and  
Recommendations (needs work, healing, leave alone, watch?):

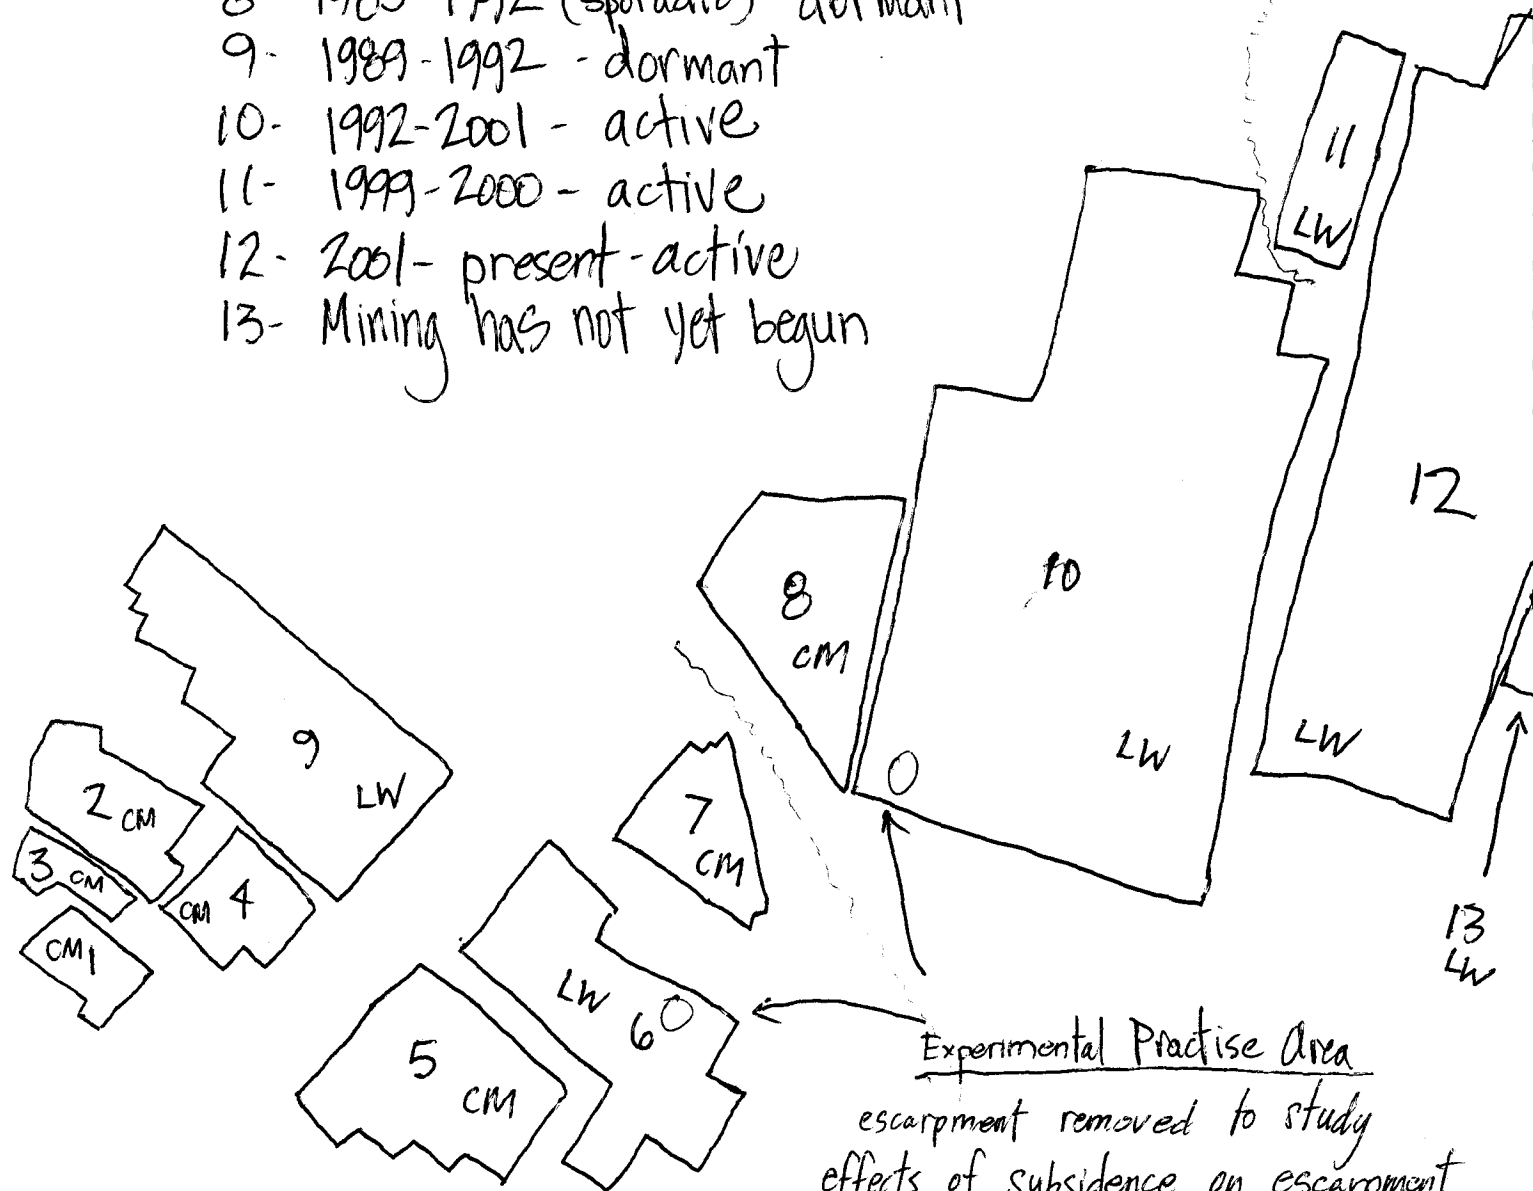
Some cliff spalling occurred in panel 6 in 1988 above 3 room & pillar panels  
 cliff spalling & tension cracks occurred in panel 10 above longwall panel

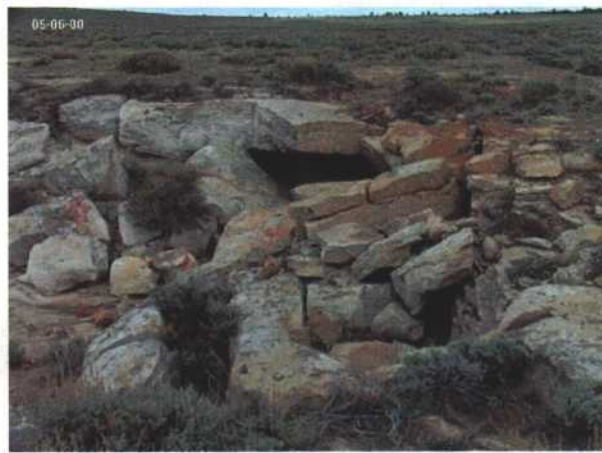
Figure 3 Before-May 6, 2000

This site was undermined on 3/26/02. This cultural site had numerous natural rock failures before it was undermined (Fig. 1 & 3). Subsidence impacts were about what was anticipated when the monitoring program was initially set up. Subsidence impact resulted in the overhanging rock on the right side, that already had a large crack on the backside, breaking loose and falling in. The overhanging rock on the left side rolled into the opening (Fig. 2 & 4). The overhang on the left side could have already been cracked similar to the right side since it broke across on the same crack line. How much the site has subsided is not know yet. The subsidence will be measured over the next few weeks.

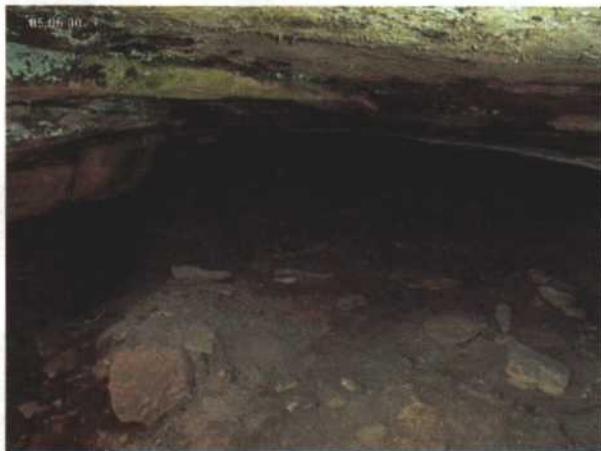
Figure 7 Before-May 6, 2000

This site was undermined on 3/22/02. Subsidence impacts were not what was anticipated when the monitoring program was initially set up. The overhanging rock had some natural small cracks but was not broken up as much as some of the other sites and it was felt that this site would probably not be impacted by subsidence (Fig. 5 & 7). Subsidence impact resulted in the roof rock cracking in the center of the site and breaking off on the right side (Fig. 6 & 8). This is similar to what happen at the 42SV2492 150-Acre site in 2000 but not as severe. This site has not been surveyed since it subsided to determine how much the site has subsided.
